# Rocky Ford Daily Gazette

### Crew Returns Heritage To Local Congregation

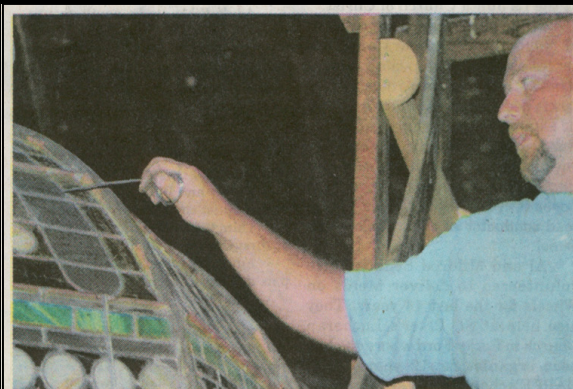
Robert Bohannon, foreman with an Associated Crafts crew, points to a portion of repairs he and his crew have completed on the stained glass dome at the CommUnity Presbyterian Church in Rocky Ford. (Photo By Susan Pieper)

The dome, however, had begun to buckle, according to Robert Bohannon, foreman with the crew from Associated Crafts based in Gilbert, AZ, thus allowing blue sky to

be visible through the dome's stained glass.

Sixteen panels form the dome and all 16 were repaired by this company which specializes in restoration and preservation of stained glass windows. The repair process involved resoldering the panels and putting in some bracing to give needed strength to the base of the dome.

Carlson physically pushed each panel back into place while Bohannon and Wiggins resoldered from above. Sounds rather simple, but the top of the dome is over 40 feet from the sanctuary floor. So, while Carlson pushed, Bohannon and Wiggins leaned over the dome, careful not to break the glass, and reworked the leading, pulling it back into place. Plus, their work surface was about the width of a plank.
